Investigation on Waterproofing Defects at

Erf 2044, Green Point

House Noth

Report – Rev 00

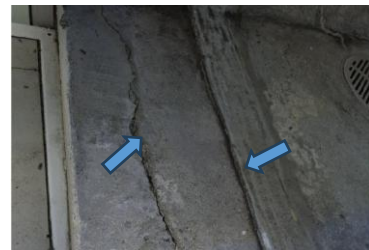
Pic 07: Cracks in concrete slab above house entrance on 2nd Floor.

No stormwater channel is installed at the lower end of the slab. Rainwater is reported to flow over the entrance to the house and infiltrates the cracks as indicated on **Picture 07** above.

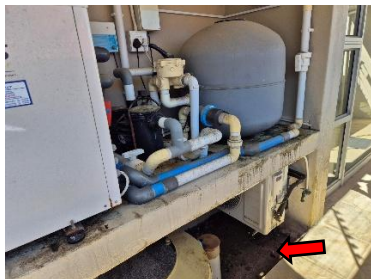
Pic 08: No concrete surface below HVAC equipment on Ground Floor.

However, within this project, it is proposed that a 75mm concrete slab be constructed under the swimming pool pump with a slope towards the ground floor passage as detailed on the drawing attached as **Annexure A**. location of the proposed slab is indicated on the image below.

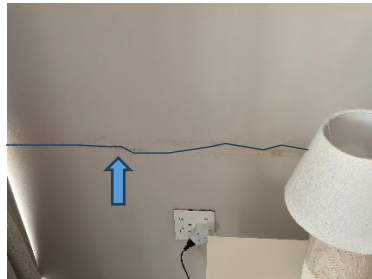
Pic 09: Water ingress in wall of lower bedroom.

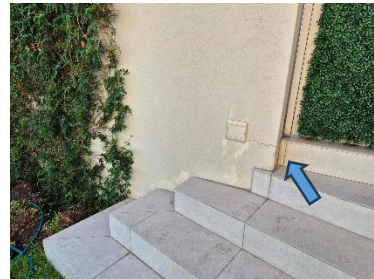
Pic 10: Rainwater from the adjacent stairwell entering the property.

Rainwater entering the property via stairwell gates located on the eastern border of the property on the ground floor and 1st floor of the building as indicated on in **Picture 10** above, adds to the damp and ingress of water into the walls and floors of the building.

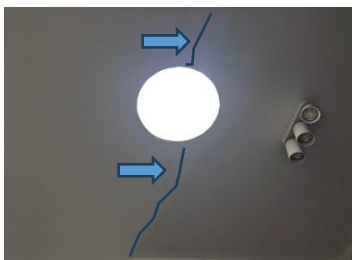
Pic 11: Crack in concrete slab of planter box housing the skylight

It is recommended that the Homeowner further investigate the following possible future causes of water ingress at locations where structural cracks and other non-waterproof related damages were observed.

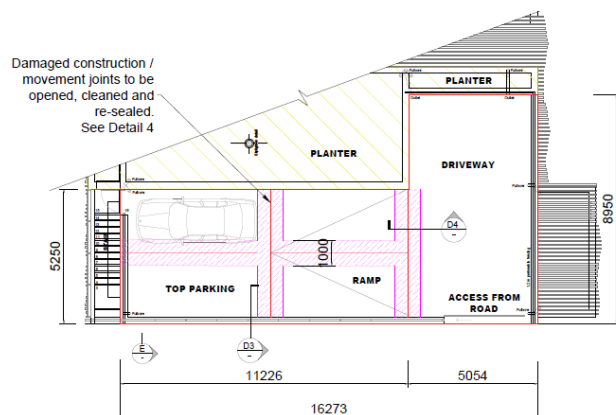
PARKING AREA ON ROOF

The exposed concrete driveway on the top of the building shows large sections of degrading. Waterproofing on the edges of the slab and upstand beams is of sub-standard and needs to be repaired as per the details outline in Detail 3 and Detail 4 of the attached drawing as **Annexure A**.

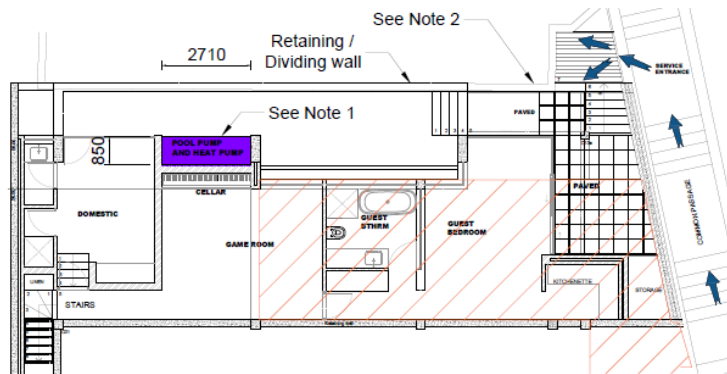
GROUND FLOOR

All stormwater accumulated on the roof (top level of the building) and areas around the swimming pool are channelled via fullbores strategically situated within the building framework, however, run-off stormwater from the common passage (eastern stairwell) enters the property for which no stormwater management is planned.

1. Cast 75mm thick Class 15/19 concrete floor with Ref 395 mesh to slope to passage
2. Water damp to Retaining / Division wall with neighbour emanating from standing water on neighbour's adjoining building roof. This issue to be deliberated between Homeowners, building roof brought to spec and wall re-plastered and painted thereafter.
