PROJECT SCOPE and INVESTIGATIVE NOTES

PROJECT TITLE
Structural Engineering Investigation Services for
Erf 2044, 38R Ocean View Drive, Greenpoint
(House Noth)

DRAWING TITLE
Investigation Notes and Concept Proposed
Remedial Detail

Drawing number: HNoth - Struct 01
Drawing size: A1
Rev: 00

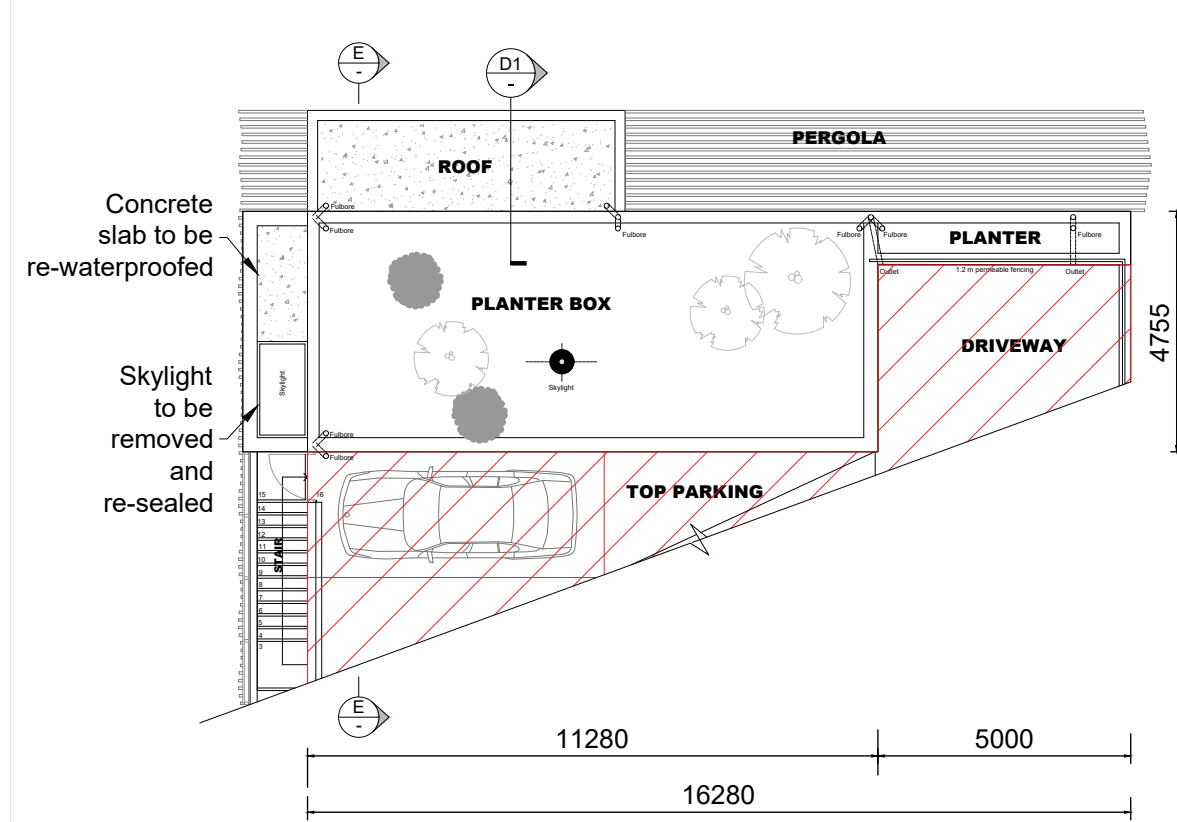
PLANTER BOX, SKYLIGHT and CONCRETE SLAB ON ROOF

ACTIVITY A: Re-waterproofing - Planter Box, Skylight, Concrete Slab and Grassed areas

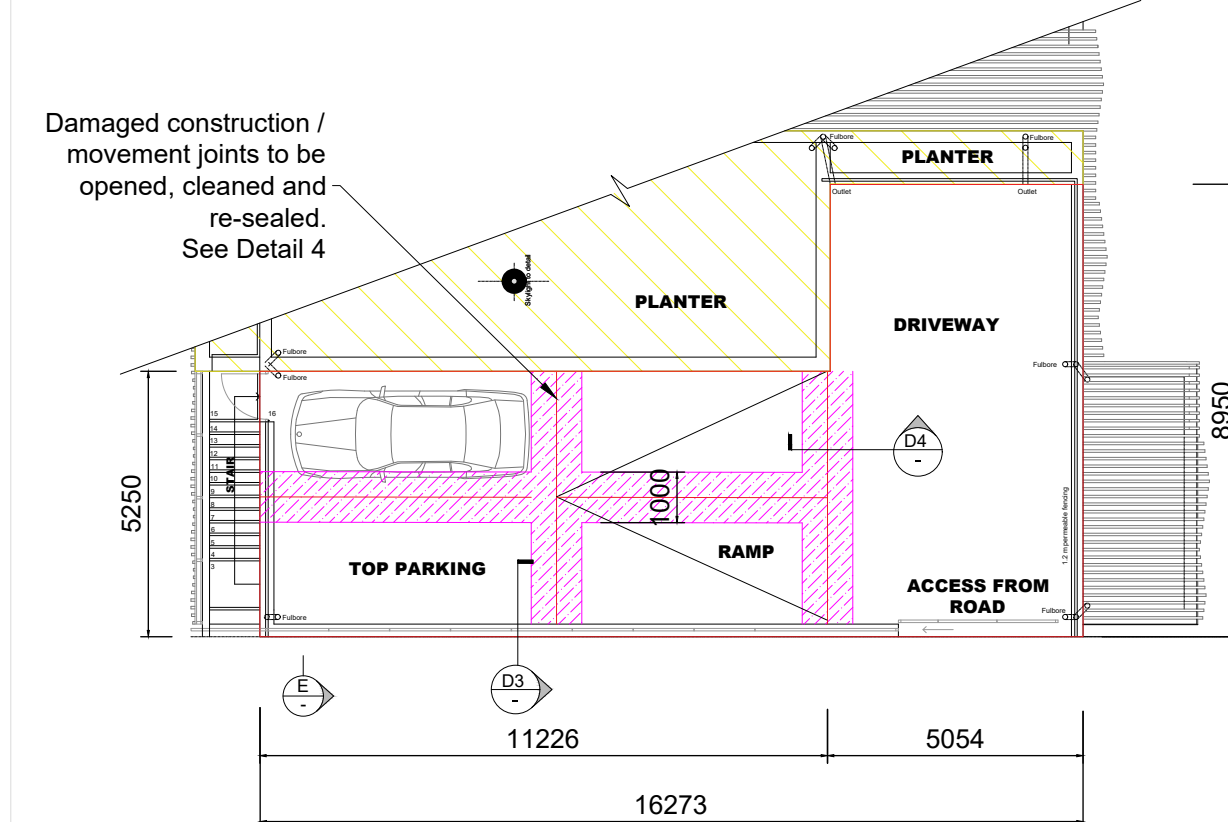
PARKING AREA ON ROOF

ACTIVITY B: Repair Concrete Driveway / Vehicle Parking

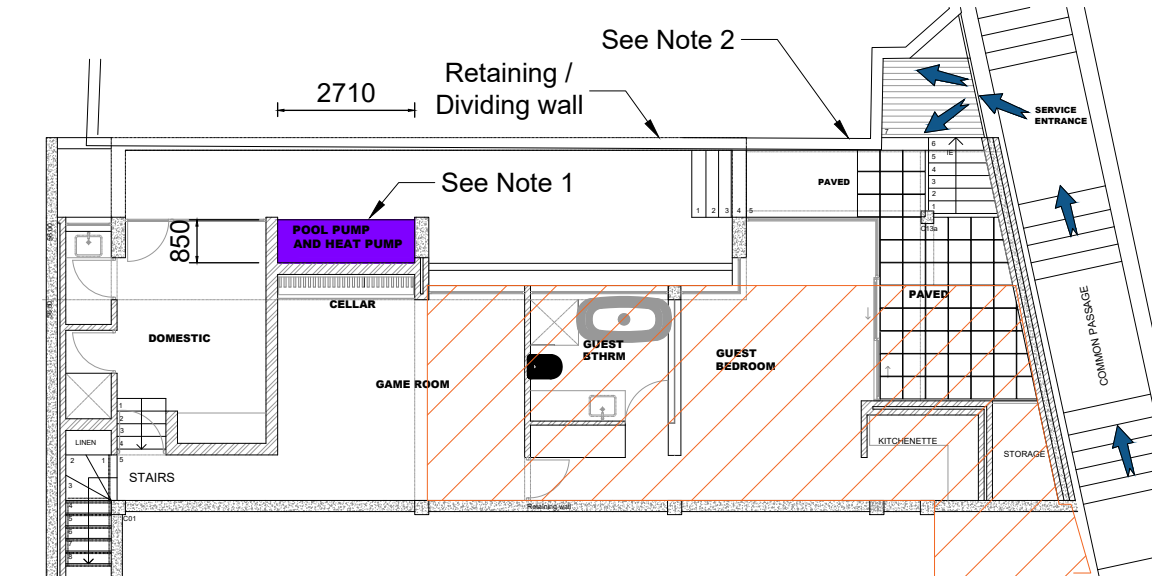
GROUND FLOOR

ACTIVITY C: Stormwater management - Ground Floor

- Cast 75mm thick Class 15/19 concrete floor with Ref 395 mesh to slope to passage
- Water damp to Retaining / Division wall with neighbour emanating from standing water on neighbour's adjoining building roof. This issue to be deliberated between Homeowners, building roof brought to spec and wall re-plastered and painted thereafter.
