**REPORT
FOR
HOUSE DE RUST
PARYS GOLF & COUNTRY ESTATE,
PARYS
9585**

Malindo Civil and Construction Pty Ltd was appointed by the National Home Builders Registration Council (NHBCRC) to compile a report on the defects and conduct remedial works of house **De Rust** in **Parys Golf & Country Estate**, located in Parys, Free State Province, South Africa.

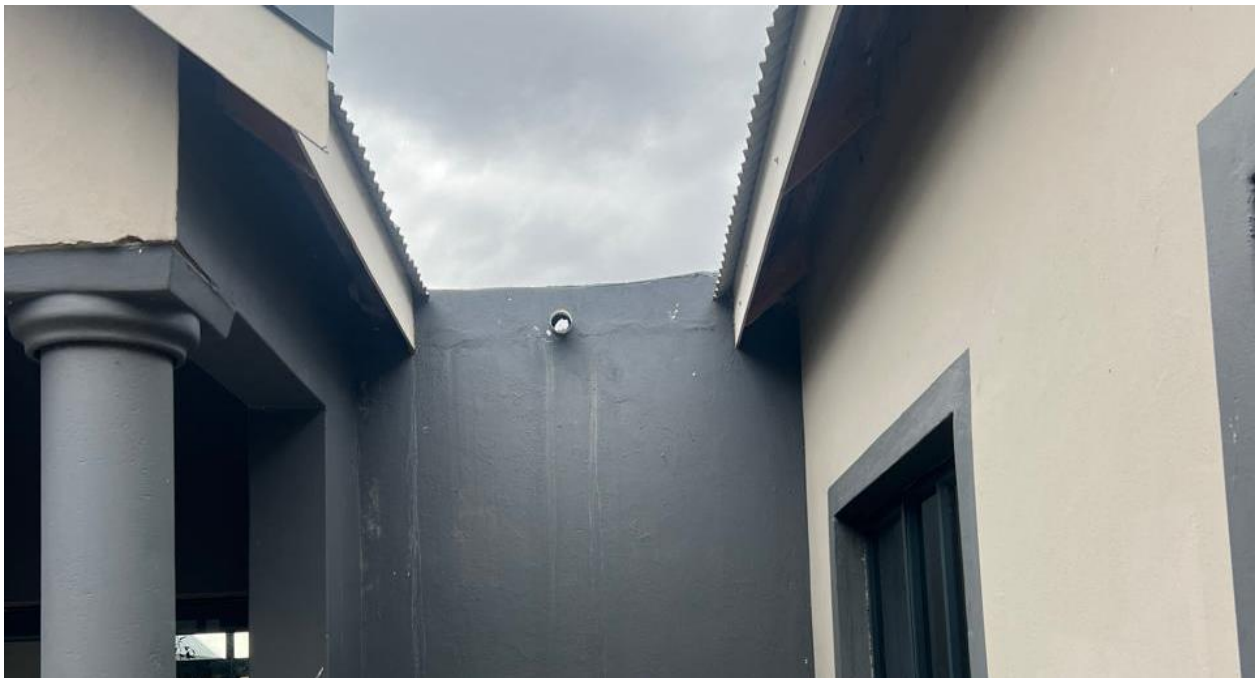
Figure 2: Front elevation of flat roof with moisture damage and cracks

Both the flat roofs have less than required retention depth to allow enough water to be stored while draining takes place, resulting in the defects displayed in figure 2 above.

4.1.1 Flat roof were supposed to be built at least 400 mm lower than start of pitch roof.

4.1.2 Roof sheets are joined to flat roof waterproofing membrane resulting in water ingress.

4.1.2 Fewer weepholes that SANS10400-L:2011 Edition 3 section 4.3 figure 2 that requires 1 outlet for every 3 m x 4 m.

4.1.2 Moisture damage on the walls.

4.1.3 Poor drainage slope of existing screed.

4.1.4 Cracks on parapet walls (see figure 2 and 3).

1. Remove existing waterproofing and screed (the removal of existing screed shall be such that new shallow results with 100mm weather step).
2. Add 2 more 110 mm diameter weep holes resulting in 3 per slab.

3. Reinstall screed and waterproofing.
 - a. Surface Preparation
 - b. Ensure that the slab is clean, dry and free of all contaminants and correctly prepared.

- c. All dust and loose friable material must be removed.
 - d. Blow holes and voids should be fully exposed then repaired.
 - e. Install a new 20 MPa screed with a 5% minimum slope lower than current level to improve temporary retention during a storm.

- f. Clean substrate before applying product.
 - g. Apply Sika Black Seal Primer Coat or similar approved for concrete surfaces at the correct consumption to the prepared surface and allow to dry.

- h. Place Sika Index VIS or similar approved
 - i. Unroll the torch-on and align it before torching or bonding.
 - j. Each membrane must be laid parallel to each other and must be staggered by at least 1 m to avoid coinciding joints.

- k. The end-to-end overlaps must always be alternate, never arranged along a single line.
 - l. Always start on the lowest height of the slope and with the drains, the downpipes or other details.

- m. The torching of the rolls must heat the membrane and the substrate at the same time, concentrating on the roll and the overlapping.
 - n. The overlaps must be welded with great care until a trickle of melted mixture about 1 cm wide can be seen coming out along the line of the overlap.

- o. Final Top Coat (Clean substrate before applying product).
 - p. Apply Sika BlackSeal Silvercoat (or similar approved) coating can be applied by a brush or roller.

- q. New waterproofing to wrap 230mm brick to avoid water absorption in case of overflow.
4. Remove plaster and repair horizontal cracks on the parapet walls.

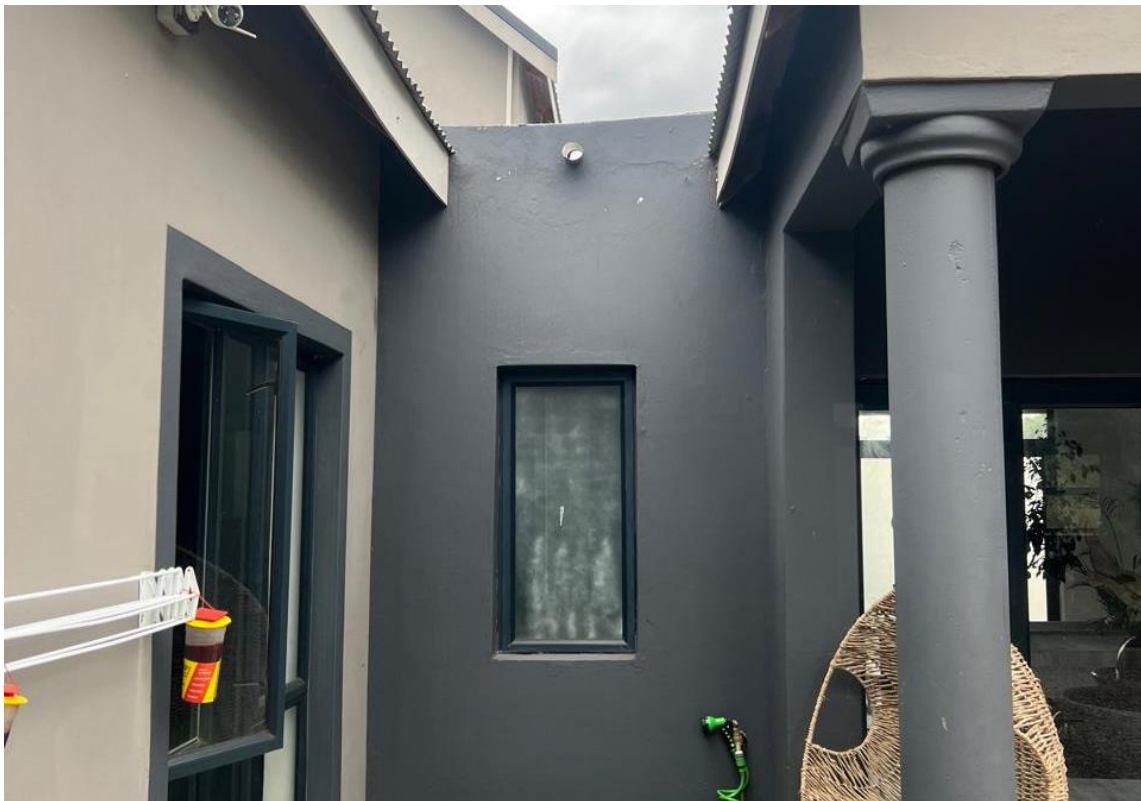
Figure 3: Front elevation with horizontal parapet wall crack

- a. Masonry cracks:

- b. Clean all loose material and dust.
 - c. Install diamond mesh (1000mm wide) or similar approved using 6mm easy drive nails with 20mm washers to hold mesh in place.
 - d. Mesh to be installed after all weepholes are installed to prevent any cracking.
 - e. Apply plaster prime at 5m²/litre or as per manufactures' instructions
 - f. Re-plaster over mesh with class I plaster mortar.
- 5. Repaint all affected inside walls from corner to corner and the affected slab under side.
 - 6. Repaint outside wall from corner to corner.

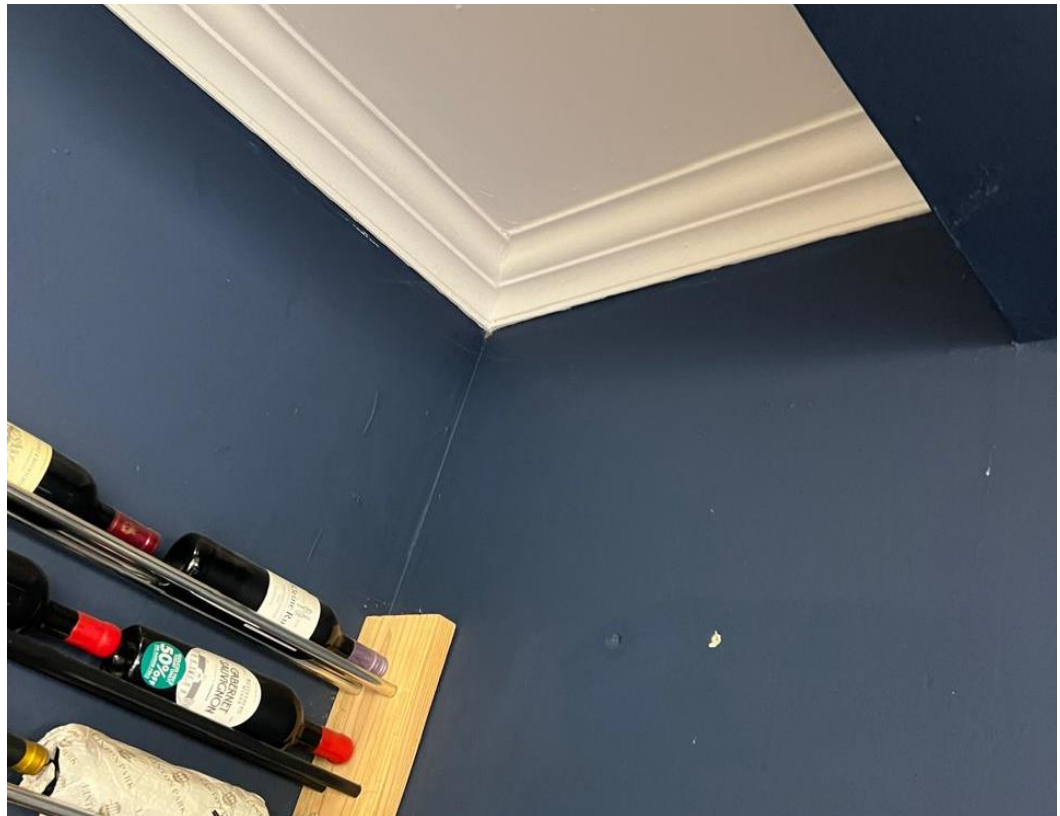
Figure 4: Internal moisture damage

The flat roofs were constructed with no temporary water retention during storms and fewer weepholes to the recommendation of SANS10400-L:2011 Edition 3 section 4.3, resulting in the moisture damages due to leaks. Cracks noted are resulting from moisture penetration due to poor construction practises.

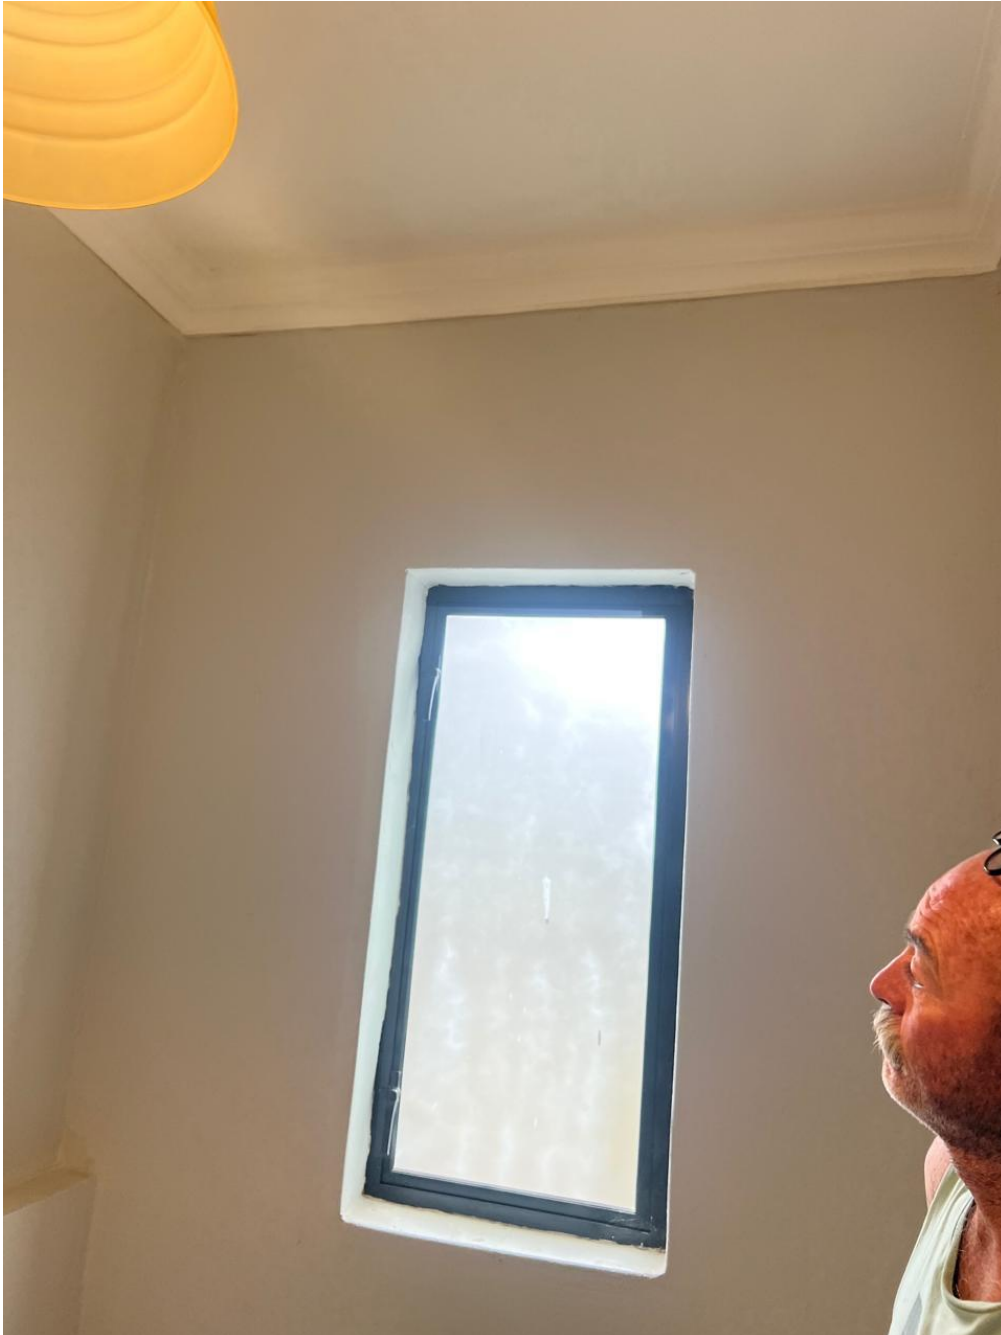
Figure 5: Internal damages

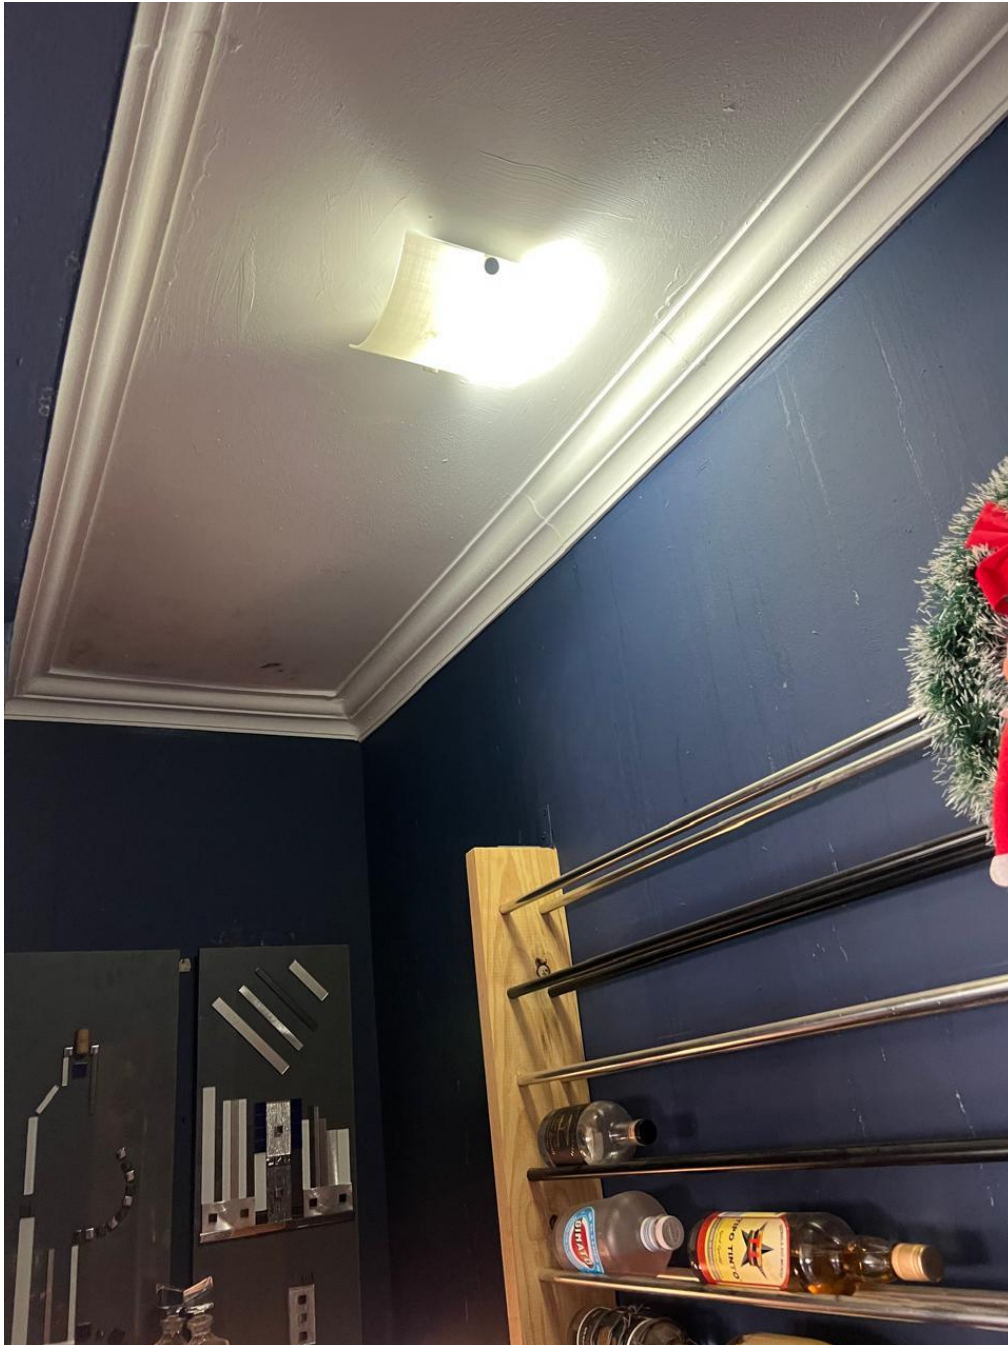
Figure 6: Internal moisture damages along the slab
