**ERF 2806, UNIT 1, WESTERN VIEWS, WESTERING,
PORT ELIZABETH EASTERN CAPE**

CREATED BY:	
Name:	Anton Marais <i>Pr.Eng</i>
Position:	Regional Engineer
Date:	22 May 2025

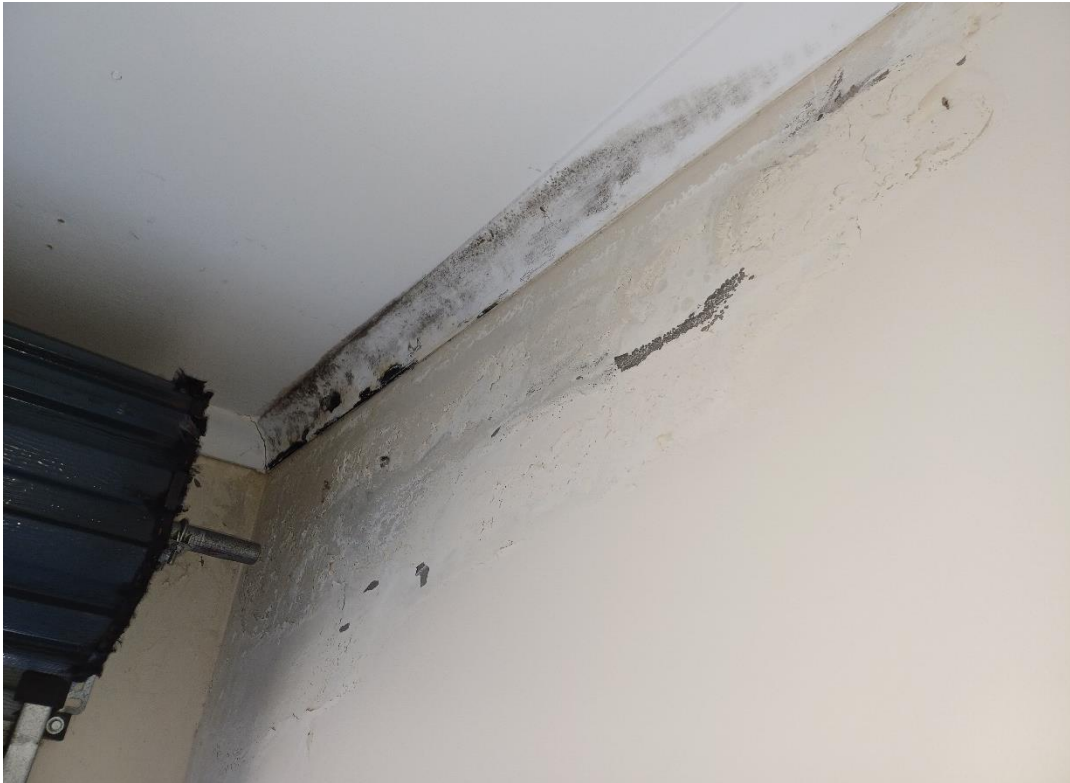
- 5.1.1. At the western corner of the garage next to the garage door water damage is visible on the masonry walls as well as the ceiling and cornice.
- 5.1.2. At the south corner of the garage on the southeastern wall the cornice has pulled away from the wall and minor damp damage is visible on the cornice.
- 5.1.3. In the southeastern wall where the control joint joins the cornice water damage is visible on the ceiling, cornice and wall.
- 5.1.4. A meter from the northern corner of the garage, water damage is visible on the cornice and wall.

Figure 3: Damp damage at the western corner of the garage.

- 7.1. The water damage on the ceiling, cornices and walls is an indication of moisture entering the garage through the roof edge behind the parapet walls.

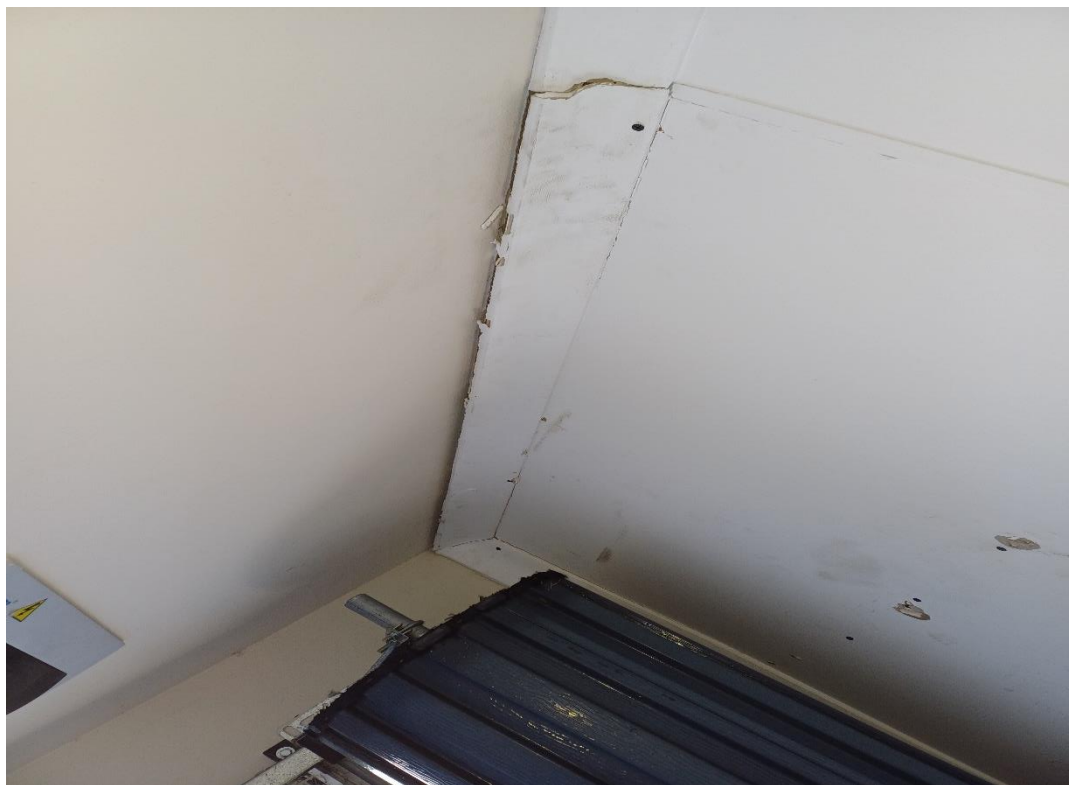
Figure 4: Water damage on cornice in southern corner of garage

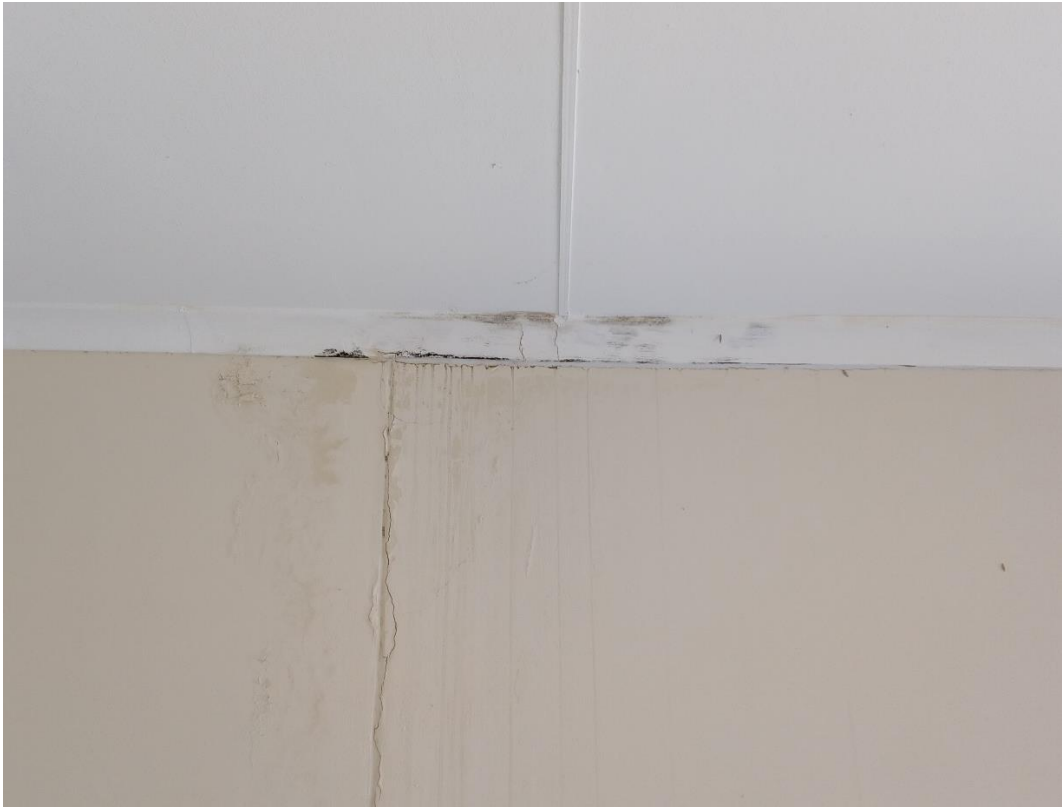
Figure 5: Water damage at control joint on southeastern wall of garage.

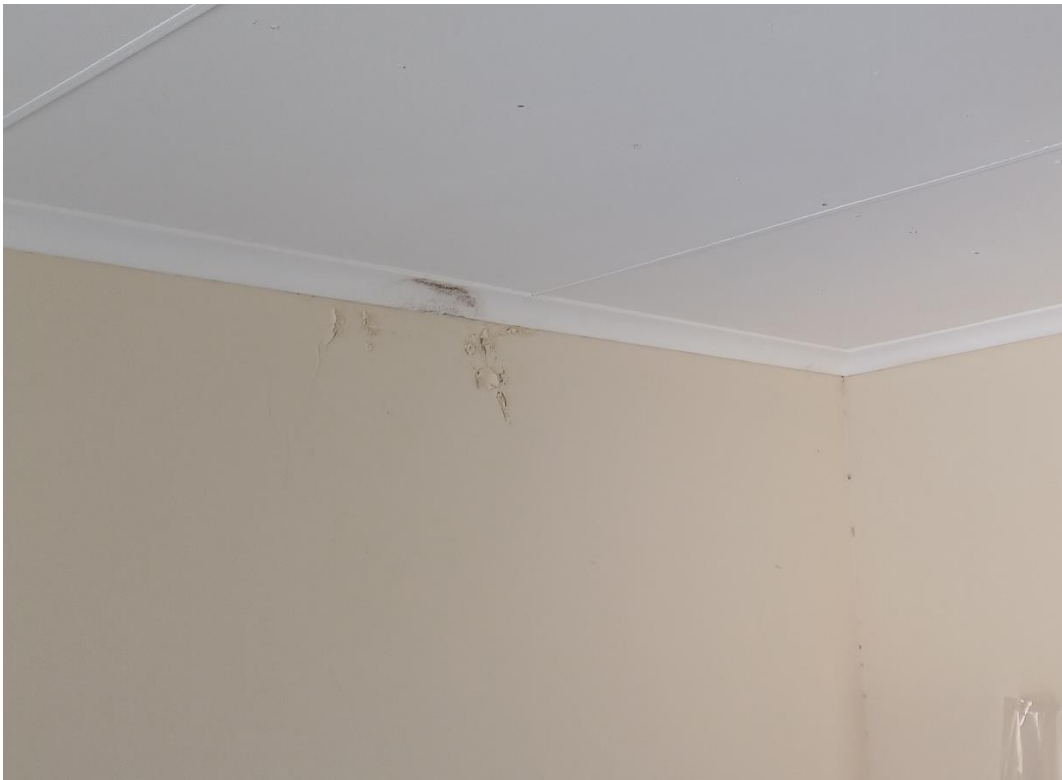
Figure 6: Water damage on the northwestern garage wall at the cornice.
