**Erf 8341, 10 Mulberry Avenue,
Jeffreys Bay, Eastern Cape**

TABLE OF CONTENTS**PAGE NO.**

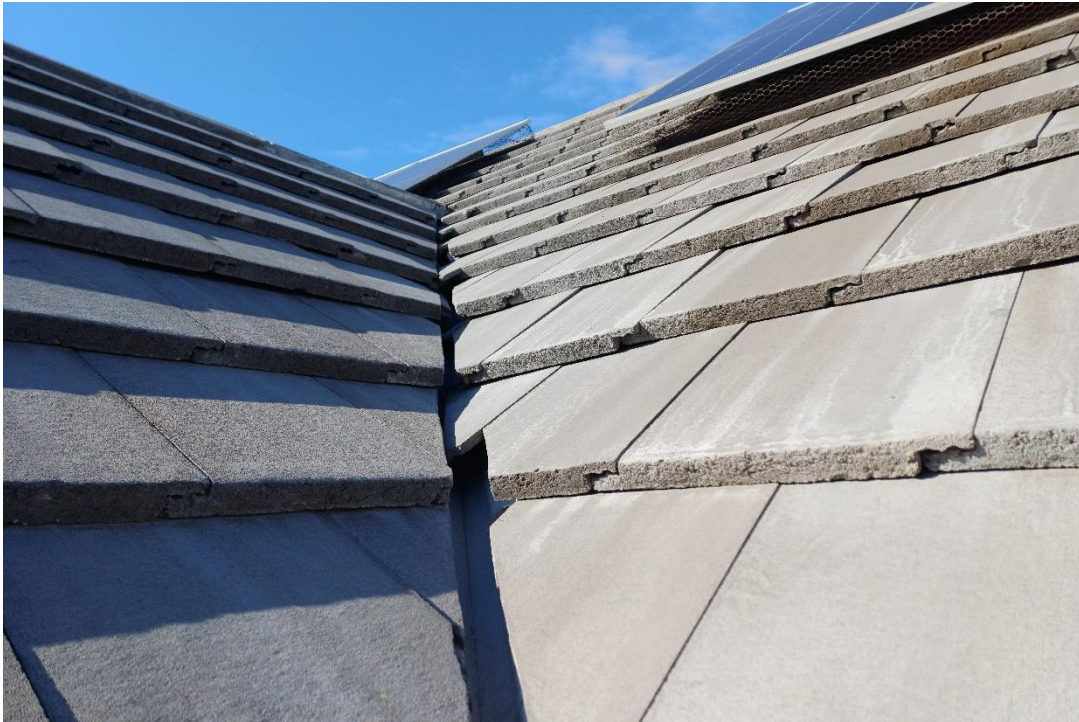
Figure 2: Roof tiles loose and slide out of position over valley gutter.

- 6.1. The roof tiles are all loosely laid on the purlins and no nailed down roof tile was identified.
- 6.2. The roof pitch is between 40 and 45 degrees, and the house is in a coastal area and as such is category C roof in terms of the roof tile installation detail. This requires each tile to be nailed or clipped.
- 6.3. Most of the identified irregularities could be caused by the tiles not being nailed down.
- 6.4. The movement of tiles under wind uplift will cause areas where water would enter the roof and cause the identified roof leaks.

- 7.1. Remove tiles in the starting area and inspect quality and installation of underlay. If all is undamaged install the tiles in sequence as Coverland installation recommendation.
- 7.2. Proceed to remove all tiles and reinstall and nail down each tile and fix every alternative tile with a storm clip.
- 7.3. Remove all ridge capping to access tile and fix as above. Reinstall ridge capping.
- 7.4. Where any battens are damaged, replace the damaged battens completely.
- 7.5. Where the under underlay is damaged remove affected battens and replace the damaged underlay and battens.
- 7.6. Replace any broken tiles.

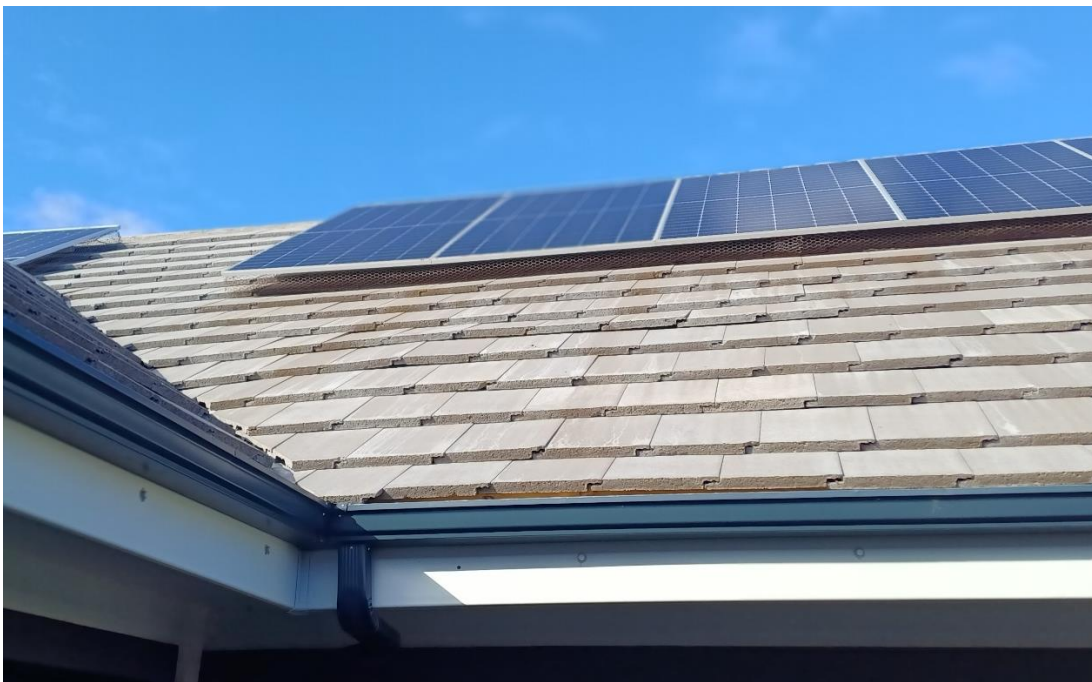
Figure 3: Tile installation not neat some tiles lifting.

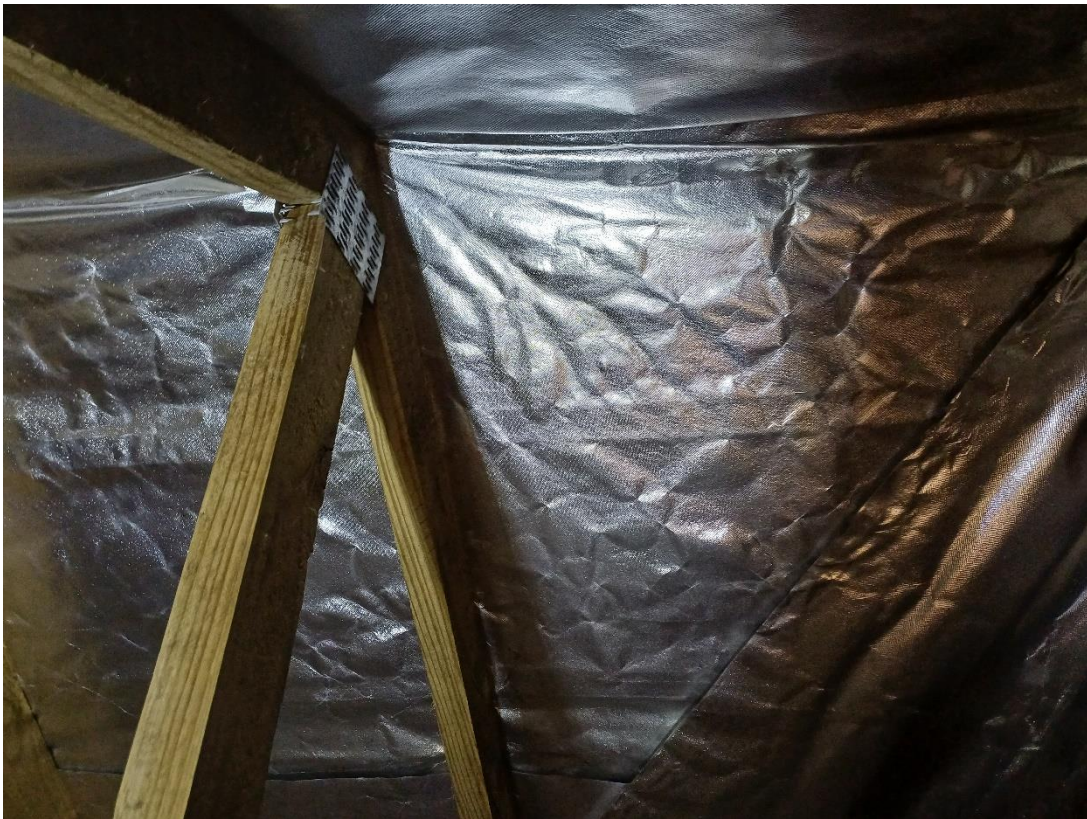
Figure 4: Undertile membrane flat and in good condition.

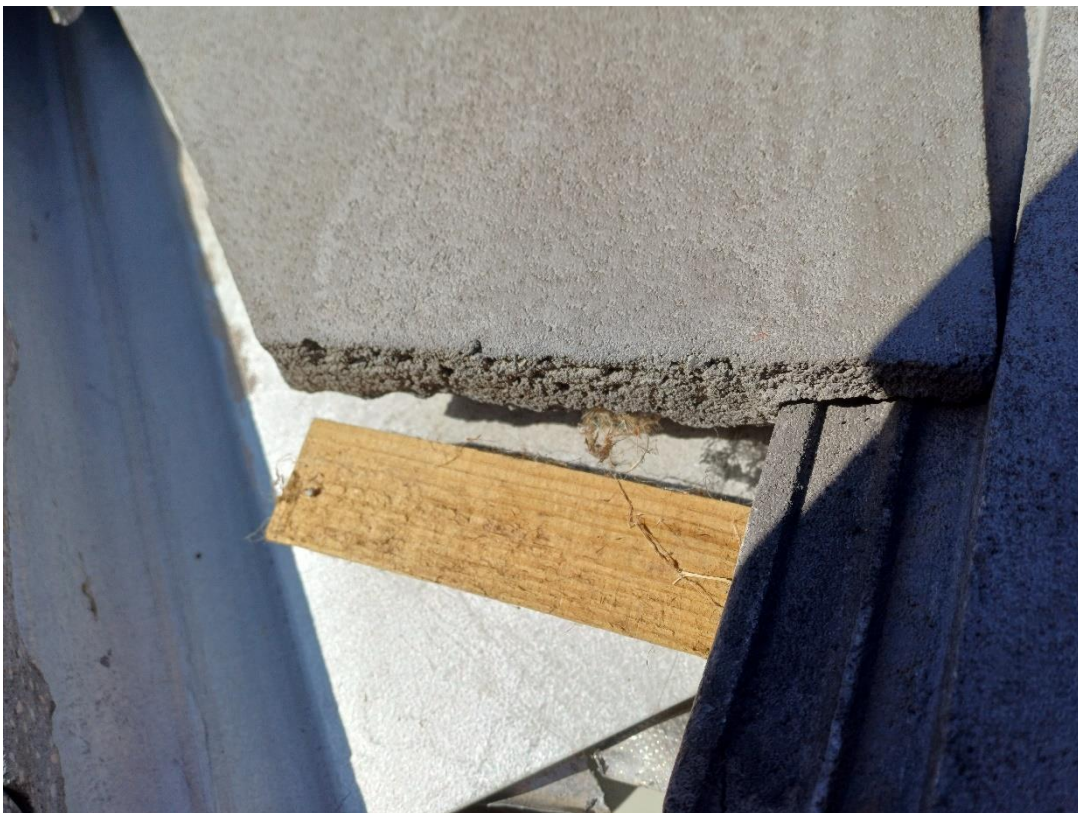
Figure 5: Loose tile pushed back exposing the batten.
