Ref: DM2025 – WC – SE - 050

Structural Engineering and Waterproofing Investigation  
to the property on Erf 19788, Somerset West

House Botes

## Report – Rev 0

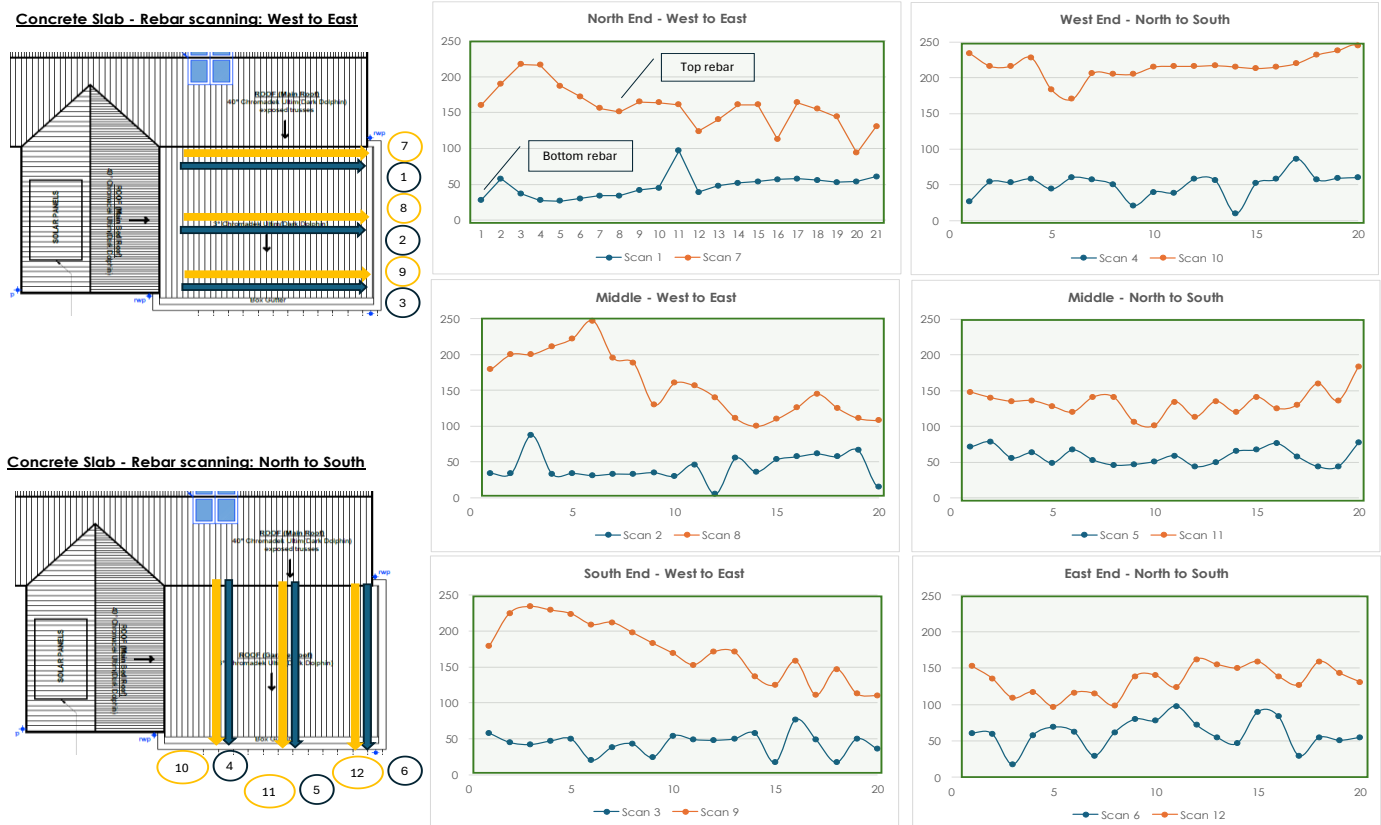
Rebar scanning of the concrete slab using a **Hilti Ferrosan PC 300** detector for rebar localisation, depth measurement and size estimation in structural analysis. The full report prepared by **Concrete Worm** is attached as **Annexure F1** which indicates irregular placing of the top and bottom rebar, also confirmed by photos taken by **EVK Consulting Engineers** during construction.

The images below is a summary of the rebar scanning conducted, also attached as **Annexure F2**.
