Ref: DM2025 – WC – SE - 041

Structural Engineering Investigation to the property
on Erf 3126, Hartenbos
House Venter

Report – Rev 0

15 October 2025

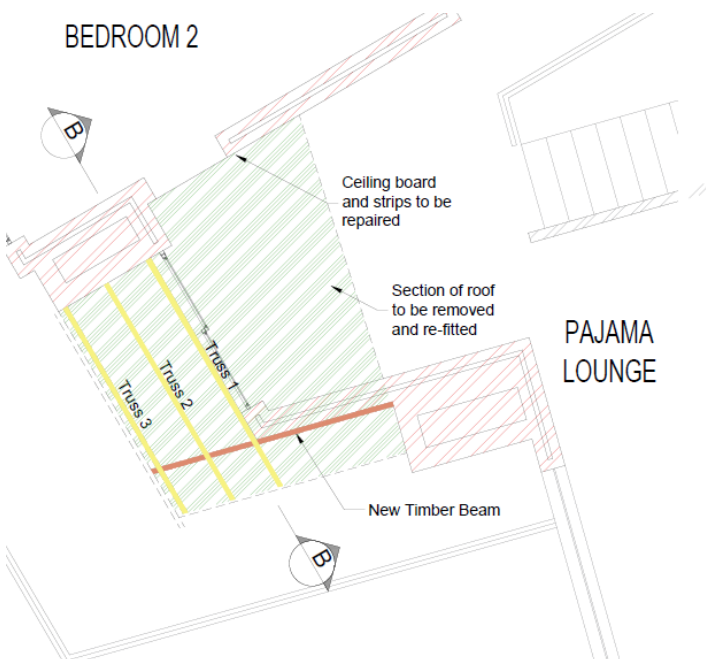
DETAIL 1: TYPICAL TRUSS DETAIL - TRUSS 1
New Truss Design

All indications are that the timber beam in support of the balcony roof assembly has deflected, or the 3 x anchor bolts used to fix the timber beam to the external building wall, may have come loose during windy and abnormal rain conditions.
