PROJECT SCOPE and INVESTIGATIVE NOTES

Client: NATIONAL HOME BUILDERS
Project Description:
Structural Engineering services for
ERF 3126 - Bloukrans Street, Hartenbos:
House Venter

Repair to First Floor balcony roof

DRAWING NO. HVenter-Struct-01/00
Rev.

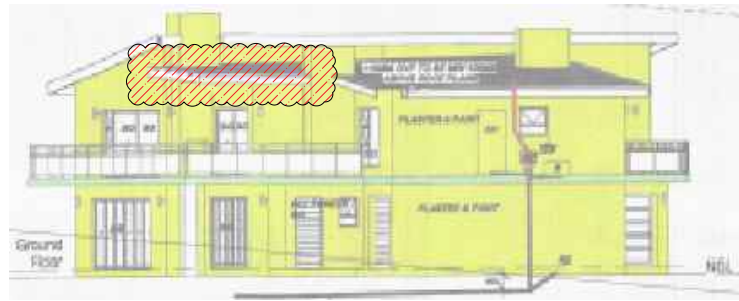
FIRST FLOOR PLAN
Location of defects
Scale 1 : 100

1 Existing Patio roof ceiling with fascia.
2 Timber truss in support of Patio roof canopy.

3 Metal roof sheeting sloping to one side.

4 Damaged roof flashing and ceiling boards strips.

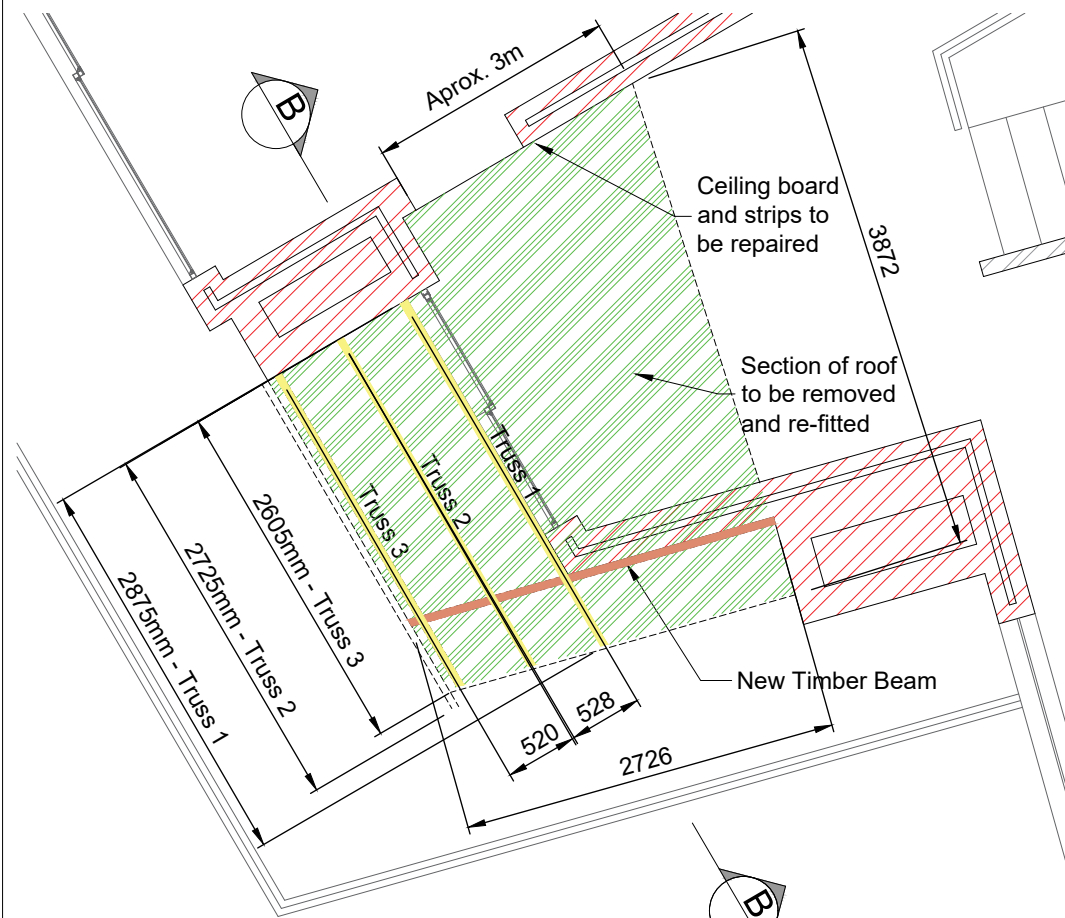
FIRST FLOOR PLAN
Truss Layout

RE- CONSTRUCT : ROOF

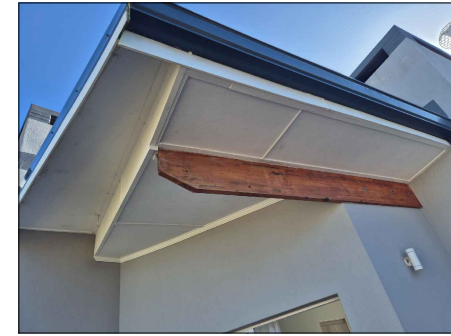
Existing configuration of Patio Roof supported by Timber beam
